### North County Line Intercounty Drain Engineering Report Wayne and Washtenaw County

Prepared for: North County Line Intercounty Drain Board

Date of report: January 14, 2020

North County Line Intercounty Drain Inspection Report December 17, 2019

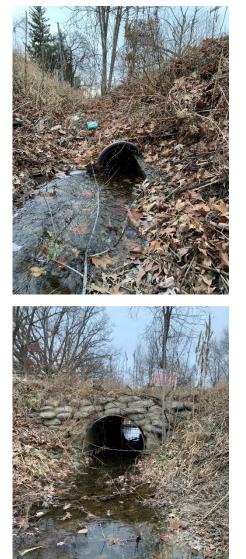
Photo #4 Rawsonville Woods Entrance - 36" RCP (lower side)

Photo #5 Rawsonville Woods Entrance – 36" RCP (upper side)

Photo #6 Driveway at 10755 Rawsonville - 36" HDPE

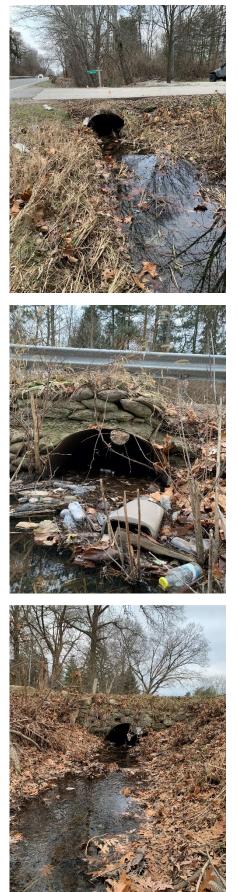
Photo #22 Driveway at 10391 Rawsonville - 36" CMP

Photo #23 Rawsonville Road Crossing - 48" CMP

Photo #24 Driveway at 10250 Rawsonville - 36" CMP

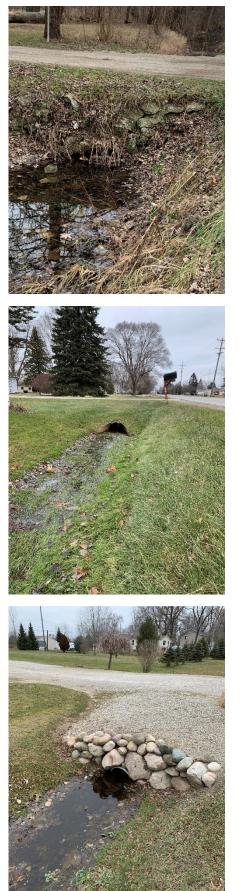
The bank of the drain is generally in fair condition with some areas of fair to poor condition. A few small to moderate washouts were observed but no major washouts. Sediment in the channel varies from 25% to 75%. Photo #30 provides a typical look of the drain bank and channel.

Photo #30 Drain Mid-Section Typical

Photo #31 Driveway at 9746 Rawsonville - 24" CMP

Photo #32 Driveway at 9370 Rawsonville - 18" CMP

Photo #33 Driveway at 9338 Rawsonville - 12" CMP

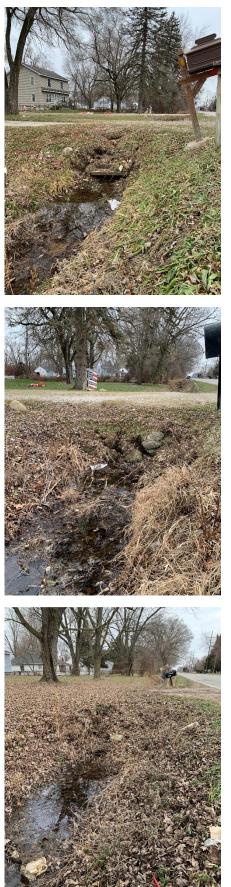
Photo #34 Driveway at 9318 Rawsonville -12" CMP mostly buried

Photo #35 Driveway at 9310 Rawsonville - 12" CMP buried

Photo #36 Driveway at 9302 Rawsonville - 12" CMP buried

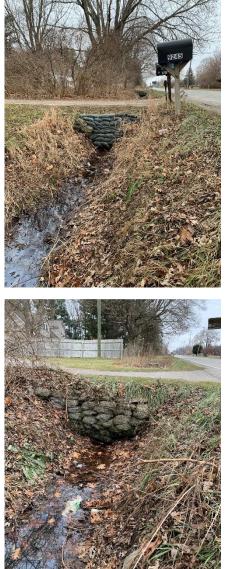
Photo #37 Driveway at 9290/9280 Rawsonville - 12" CMP buried

Photo #38 Driveway at 9258 Rawsonville - 12" CMP

Photo #39 Driveway at 9238 Rawsonville - 12" CMP mostly buried
